### Cretex PRO-RING™ Manhole Grade Adjustment Ring System

**Project:** PRO-RING™ Installation Demonstration and Endurance Test

**Location:** MH# H190029 on Putnam Pike (State Rt. 44) in Johnston, RI  
State Rt. 44 carries an average of 18,000 to 20,000 vehicles per day per RI DOT data

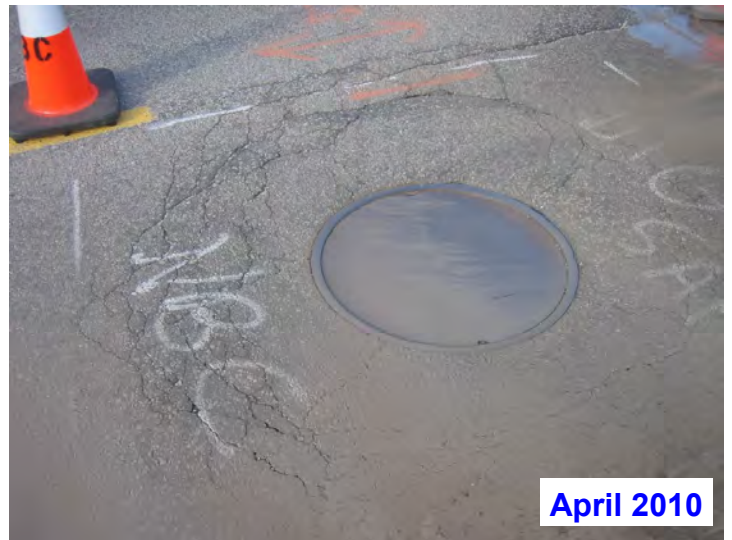
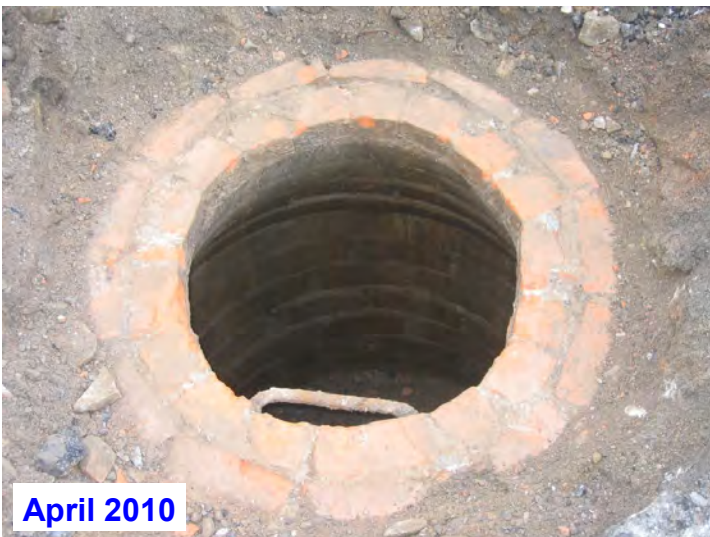
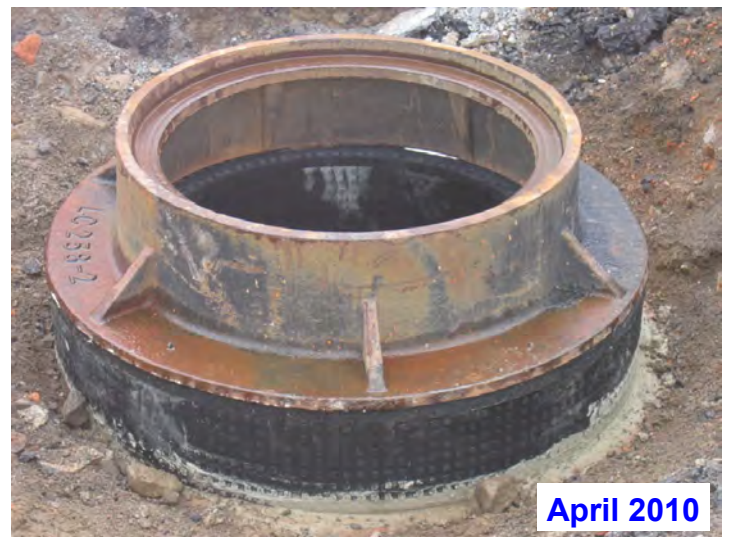
The failing pavement was saw cut and removed to expose the manhole frame and failing brick work. The frame and cover were removed and several courses of the deteriorated brick was also removed to get down to structurally sound material.

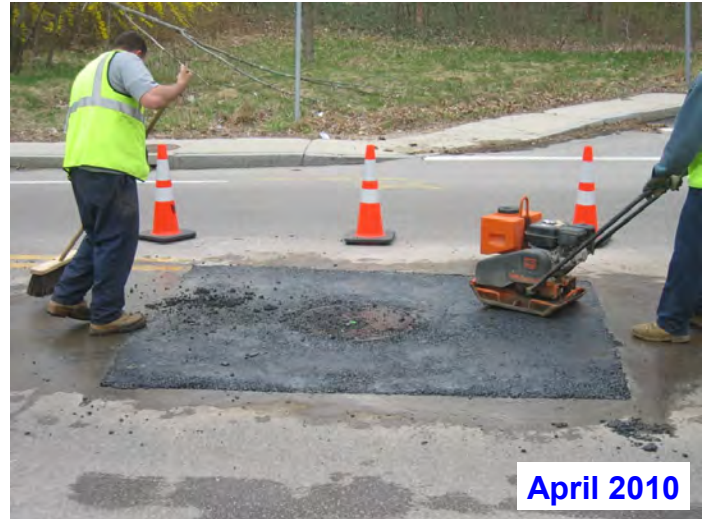
April 2010

The first PRO-RING™ used was a 6" Grade Ring to take up the major adjustment and was set into a bed of non-shrink grout to compensate for the irregularity of the brick. A 1" Finish Ring was installed next using M-1 Adhesive in the tongue and groove joint. A bead of the M-1 was then placed on the flat top surface of the Finish Ring and the manhole frame was set in place. The excavation was backfilled, compacted and the asphalt was replaced. The surface restoration was completed using a portable vibrator and traffic was immediately allowed to move over the manhole.

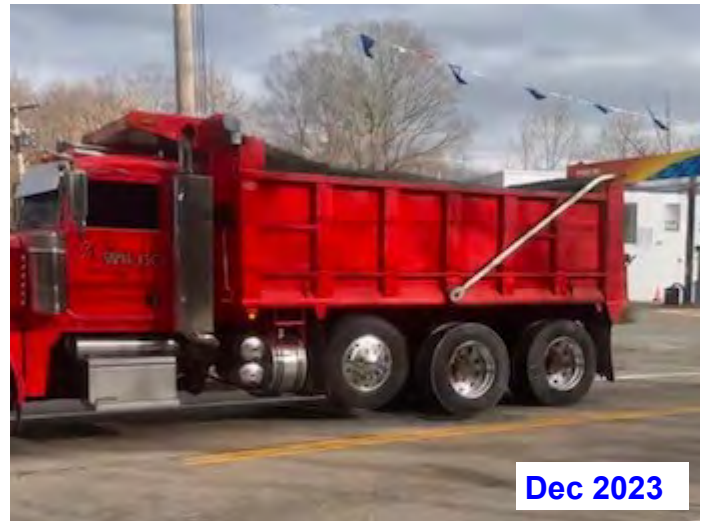
Dec 2023

**Inspection Results:** On 12/06/2023, visual inspection of this iconic Cretex PRO-RING™ installation exhibited no evidence of structural issues, deterioration or any inflow/infiltration. The surrounding pavement repair also remains in reasonably good condition with no visible cracks, or signs of fatigue or failure.
